U.S. ENVIRONMENTAL PROTECTION AGENCY  
POLLUTION/SITUATION REPORT  
2015 Gold King Mine Release SITREP

**Subject:** SITREP #4  
Gold King Mine Release

**San Juan County, Colorado**  
**Latitude: 37.8945 Longitude: -107.6384**

**From:** R8 IMT Situation Unit  
**Date:** 08/12/2015  
**Reporting Period:** 08/11/15 through 08/11/15  
**Website:** [epa.gov/goldkingmine](http://epa.gov/goldkingmine)

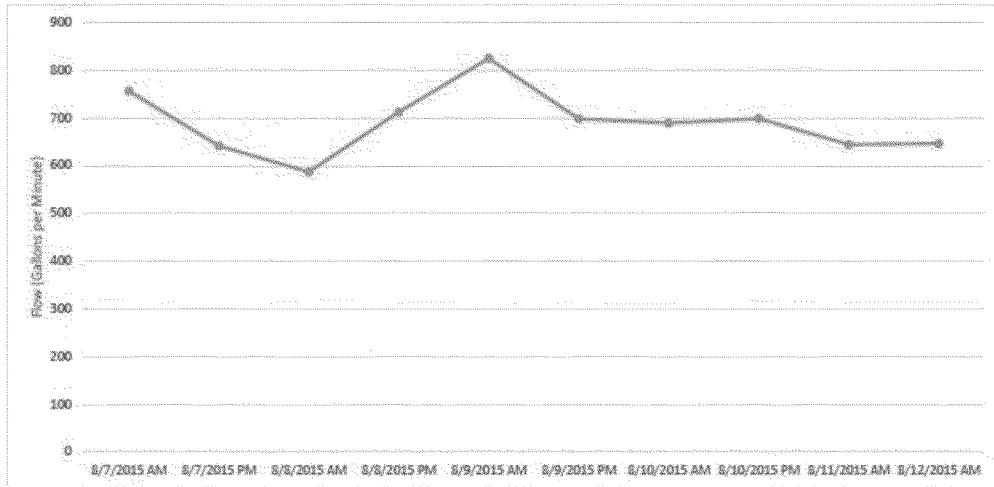
The EPA continues to operate four treatment and sedimentation ponds at the mine site which are treating water by lowering acidity levels and removing dissolved metals. Flow from the mine through the morning of 8/12/2015 is shown in the following chart.

Treated water from the last treatment pond is discharging into Cement Creek at levels cleaner (higher pH and lower levels of metals) than pre-event, background conditions in the creek. Over the next several days, the EPA will make upgrades to the system to ensure its continued operation. Flow data out of the mine is being collected manually two times per day. Water quality data is being collected at the influent and effluent of the treatment
